Manhole Inspection Summary

Manhole # S55K__070MH

Insp Date: **5/29/08 11:18 AM**

Location Address: **731 s conkling st**

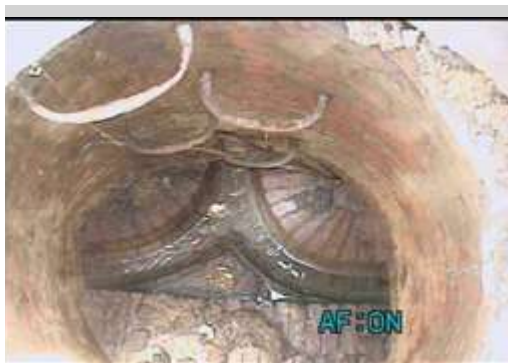
Defect 1

Condition: ☐ Sound ☐ Cracked ☐ Root Intrusion ☐ Loose Brick ☒ **Deteriorated**

Steps Count: **4** Missing: **0** ☒ **Corroded**

steps and corbel deteriorated

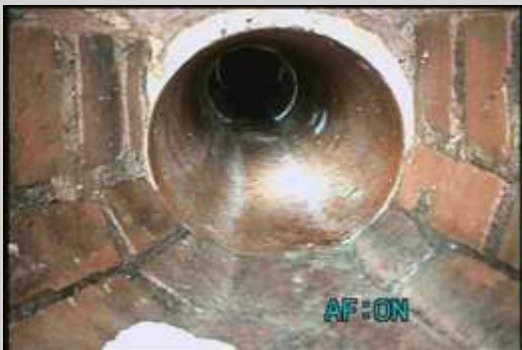
12 O'Clock Outflow

8 in. Circular Gravity Sewer
Pipe Out @ 12 O'Clock

Invert Depth: 8.00 (ft.) Flow Characteristics: **Slow**

Deposits: ☒ None ☐ Mud ☐ Sludge ☐ **Debris** ☐ Grease

Infiltration: **None** Pipe Seal Cond: **Unknown**

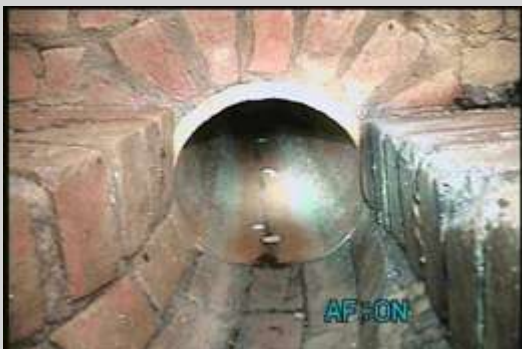
3 O'Clock Inflow

8 in. Circular Gravity Sewer
Pipe In @ 3 O'Clock

Invert Depth: 7.80 (ft.) Flow Characteristics: **Slow**

Deposits: ☒ None ☐ Mud ☐ Sludge ☐ **Debris** ☐ Grease

Infiltration: **None** Pipe Seal Cond: **Unknown**

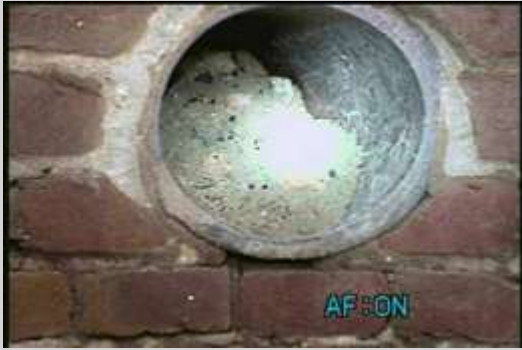
5 O'Clock Inflow

6 in. Circular Gravity Sewer

Pipe In @ 5 O'Clock

Deposits: ☐ None ☐ Mud ☐ Sludge ☒ **Debris** ☐ Grease

Silt Depth: **3** (in.) Deposits Extent: **Heavy**

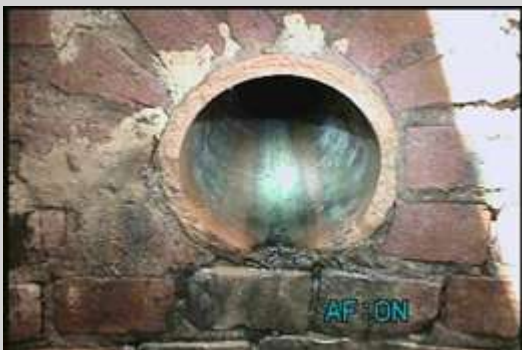
6 O'Clock Inflow

6 in. Circular Gravity Sewer

Pipe In @ 6 O'Clock

Deposits: ☒ **None** ☐ Mud ☐ Sludge ☐ Debris ☐ Grease

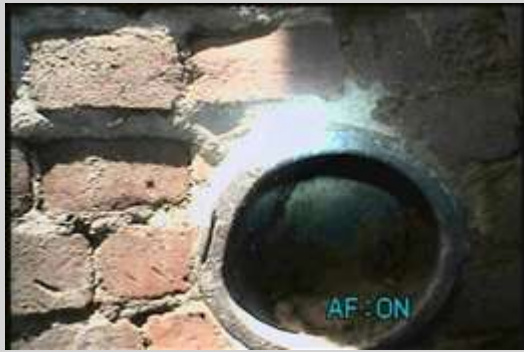
7 O'Clock Inflow

6 in. Circular Gravity Sewer

Pipe In @ 7 O'Clock

Deposits: ☒ None ☐ Mud ☐ Sludge ☐ Debris ☐ Grease

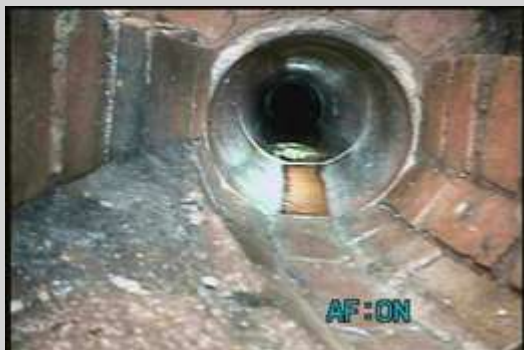
9 O'Clock Inflow

8 in. Circular Gravity Sewer

Pipe In @ 9 O'Clock

Deposits: ☒ None ☐ Mud ☐ Sludge ☐ Debris ☐ Grease
